# Case Study: Oil & Gas – Storage Tank Farms

## Composite Repair System

Oil & Gas–Storage Tank Farms

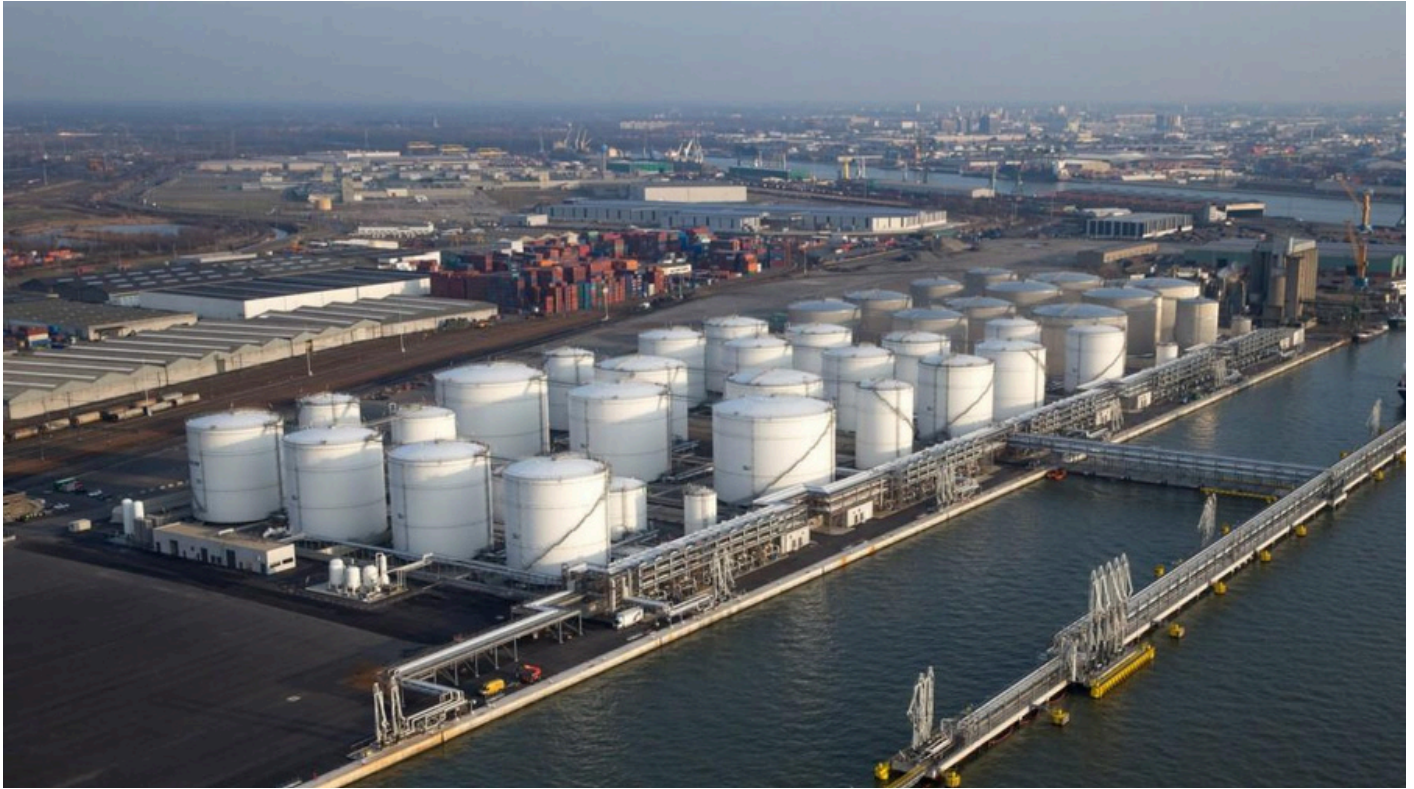
A 68 mm Diameter Storage Tank Roof with 65 locations of severe external & pitting corrosion leading to numerous through wall defects. The aim of composite repair system is to restore the tank roof upper skin plates using a patch repair process. The defect sizes were varying through wall penetrations of 10–250 mm diameter extending up to 3,000mm in length in varying locations.

After reviewing all available repair solutions, the client opted for a **composite repair system** due to its superior material properties and proven performance in restoring structural integrity. The composite system effectively reinforces areas affected by severe external and pitting corrosion, providing long-term protection against hydrocarbon exposure and environmental degradation.

Despite challenges such as high ambient temperatures, limited surface preparation (ST-3), and the need for a specialized adhesive to accommodate thermal expansion, the composite repair delivered reliable containment and durability. Having successfully utilized this technology since 2015–16, the client continues to trust the composite repair system as a preferred solution for critical tank restoration projects.
