# Case Study: Oil & Gas – Storage Tank Farms

## RD-6 – Non-Shielding Coating System

Oil & Gas—Storage Tank Farms

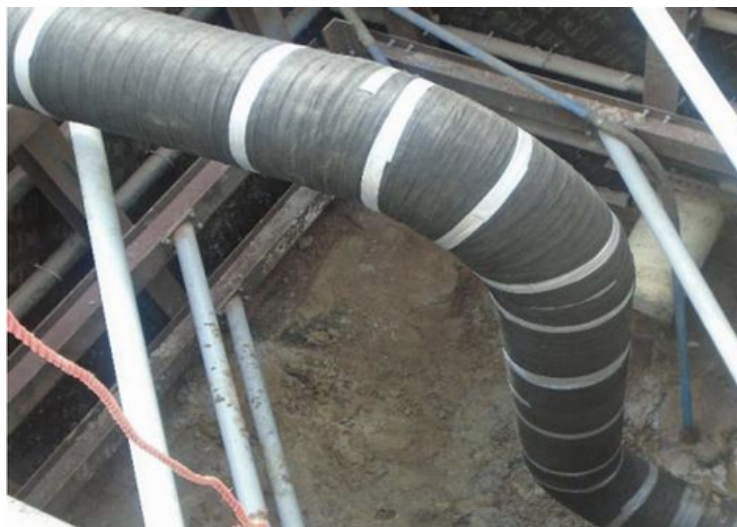
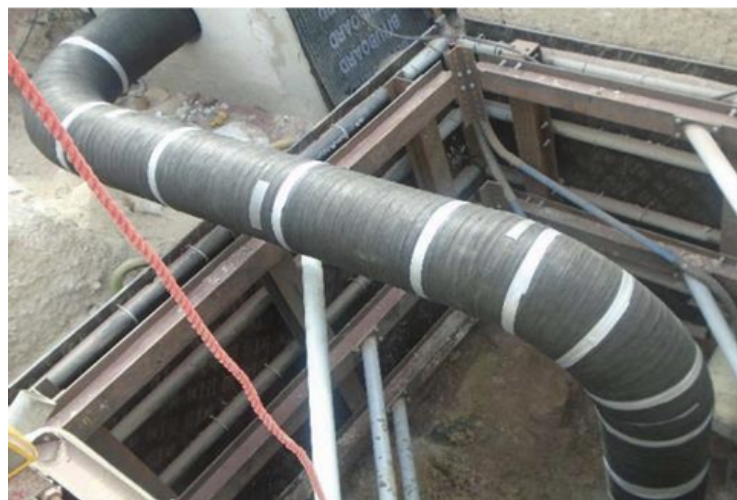
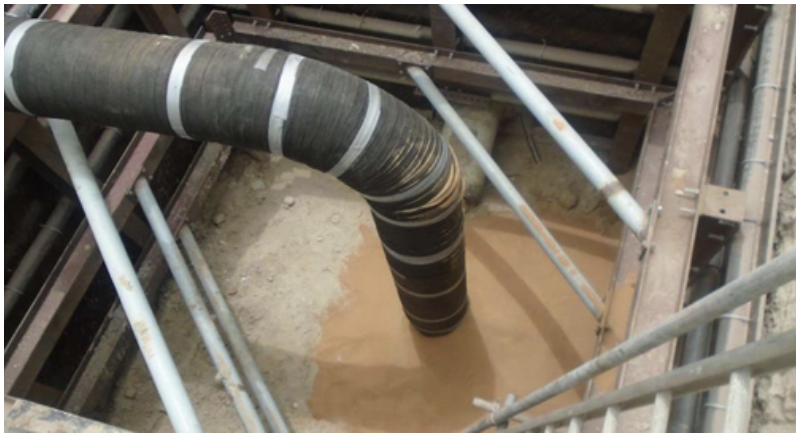
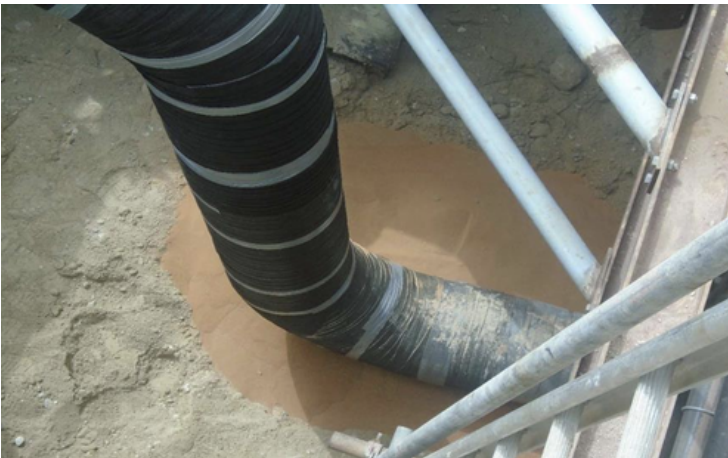
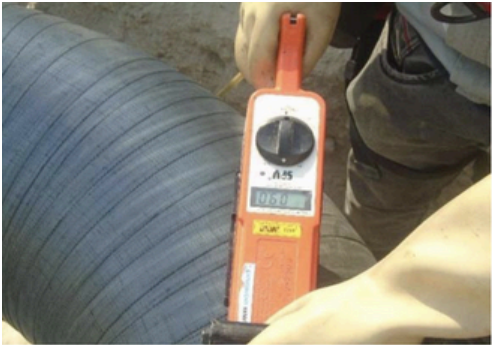
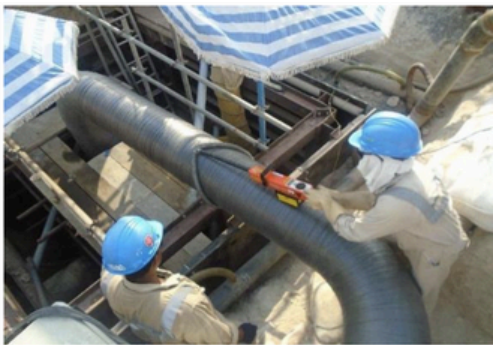
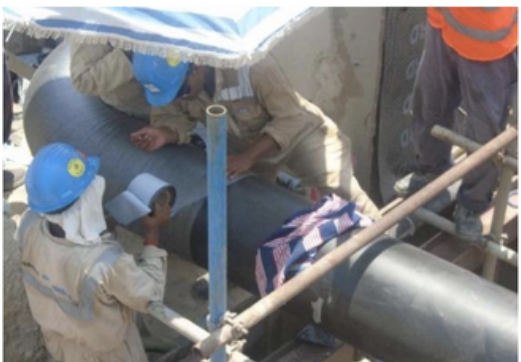
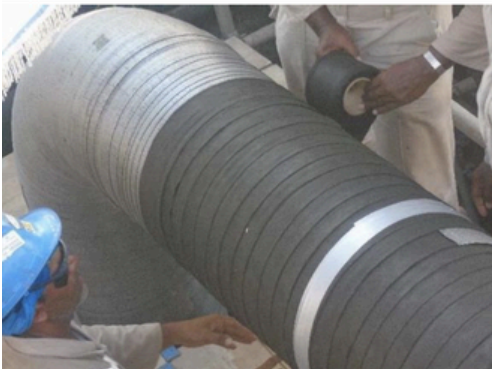
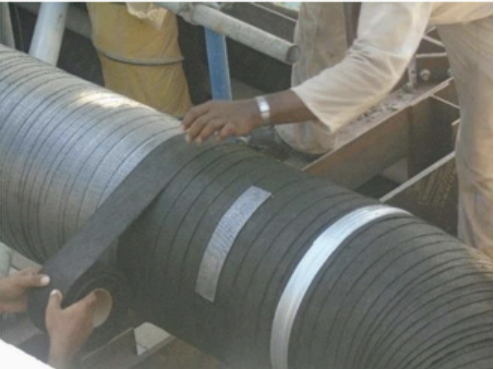
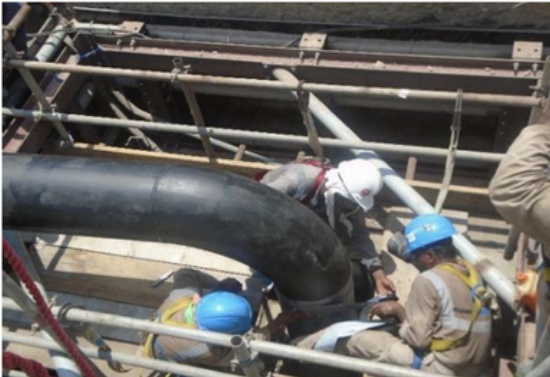
In one of the storage tanks facility the fire water line leaked because of coating system failed. The pipeline came in operation just 3 years before and in high tide, sea water on daily basis submerges the pipeline which becomes a very demanding situation for the coating system. The PE backed coating system failed and resulted in leaks and holes in the pipeline, within a span of 3 years.

1. Pipeline Diameters: 16”
2. Media: Fire Water
3. Environment: Sea water submerged
4. Original Coating: Polyken PE Tape

After evaluating multiple field-applied coating systems, the client chose RD-6 for its superior material composition and complete water ingress protection. Its strong resistance to soil stress in fluctuating water tables has made it their preferred solution since 2015–16.

RD-6 features a durable polypropylene mesh-back design, outperforming PE-based coatings in harsh soil conditions — making it the preferred choice for long-term protection.
